## **20 FINSBURY CIRCUS, 40 BLOMFIELD STREET, LONDON, EC2M**

Following investigation works to determine the cause of the fractured stonework to the ground floor columns Triton Building Conservation were appointed by Watts Group PLC to undertake the remedial works.

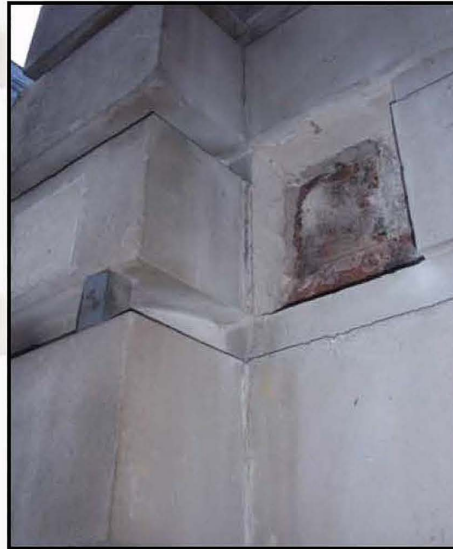
Prior to the removal of the defective stonework the pilasters were detailed to allow the manufacture of the replacement units. A number of Portland samples were provided from

Triton's stone library before agreement was made on Perryfield based bed.

During the works close co-ordination was kept with the adjacent shops to minimise any impact on their day to day trading. Following the erection of the scaffold the stone was isolated and carefully broken out to expose the rusting steel frame. This was mechanically cleaned to remove all the surface rust and treated with Epigrip epoxy aluminium primer. Once cured stainless steel restraints were attached to the steel column and isolated to prevent cross corrosion with the mild steel.

Finally the replacement stone units were delivered to site and lifted into position by means of a running beam and lewes pins. Once correctly sited each unit was bed on a lime based mortar and tied back to the restraints by means of stainless steel locating dowels and resined in position.

Upon completion of the fixing, all new stonework was repointed with crushed stonedust and Natural Hydraulic Lime.
