TRITON
RESTORATION LIMITED

The Royal Exchange Threadneedle street, London, EC2

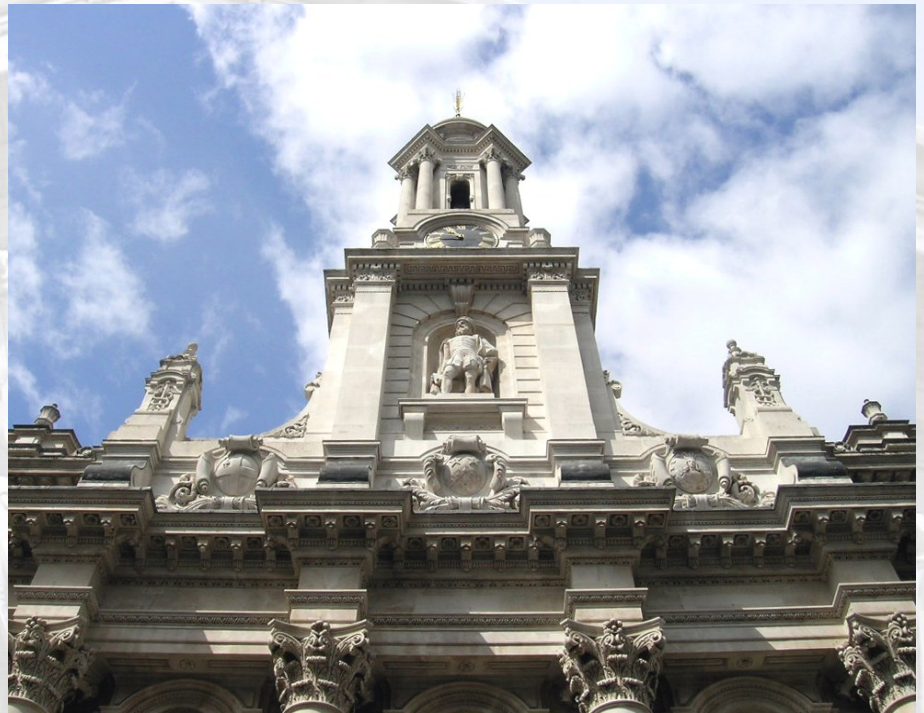
Of the statuary, only the 3 metre high statue of “Commerce” was found to be in a poor condition. The neck and shoulders were severely fractured and were re carved in Perryfield Whitbed Portland limestone.

A variety of details were also re carved, including fingers and noses, and wall panels replaced with a matching finish.
